Manhole Inspection Summary

Manhole # S13AA1035MH

Location Address: **BACK OF 3724 OVERVIEW RD**

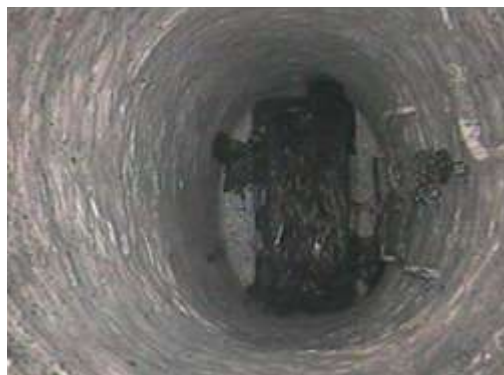
Top View

Inspection ☐ Is Incomplete Rating: **3) Fair**

Condition: ☒ Sound ☐ Cracked ☐ Root Intrusion ☐ Loose Brick ☐ Deteriorated

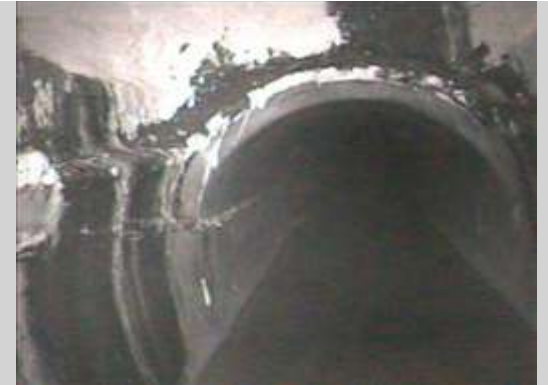
12 O'Clock Outflow

21 in. Circular Gravity Sewer
Pipe Out @ 12 O'Clock

Pipe Height: (in.) Direct
Pipe Material: **Clay** ☐ Pipe Lined
Invert Depth: **17.42** (ft.) Flow Characteristics: **Fast**
Deposits: ☒ None ☐ Mud ☐ Sludge ☐ Debris ☐ Grease
Silt Depth: (in.) Deposits Extent:
Infiltration: **None** Pipe Seal Cond: **Sound**

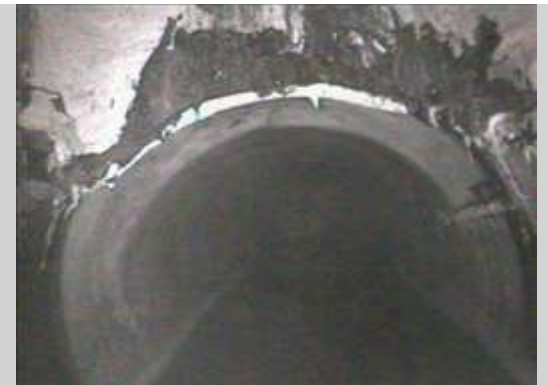
6 O'Clock Inflow

21 in. Circular Gravity Sewer
Pipe In @ 6 O'Clock

Pipe Height: (in.) Direct
Pipe Material: **Clay** ☐ Pipe Lined
Invert Depth: **17.25** (ft.) Flow Characteristics: **Fast**
Deposits: ☒ None ☐ Mud ☐ Sludge ☐ Debris ☐ Grease
Silt Depth: (in.) Deposits Extent:
Infiltration: **None** Pipe Seal Cond: **Sound**
